MAKALE_Yildiz and Sarifakioglu_Sinkholes due to gypsum

Abstract

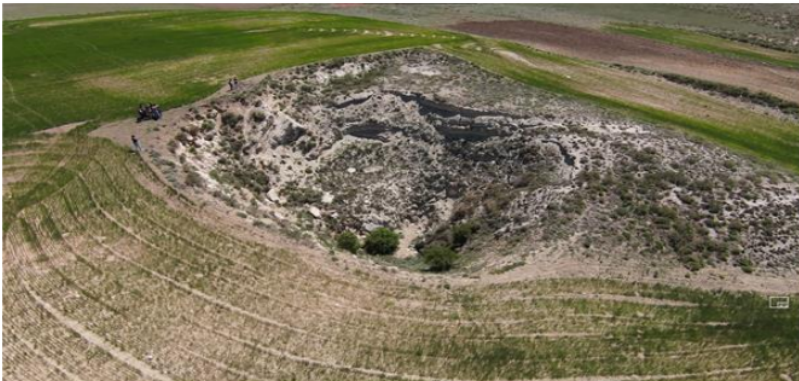
Until today, total of 8 sinkholes have occurred in the study area. The years in which these sinkholes were formed were examined before 1953 and after 1953 [4]. The oldest sinkhole has occurred before 1953 and the most recent sinkhole occurred in 2012 (Figure 3). The height of the sinkholes from sea level varies between 832 - 927 m. The diameters of the sinkholes vary between 1 - 44 m, and their depths vary between 1 - 22.5 m. Three types of sinkholes were observed in the study area. These are; collapse sinkhole, dropout sinkhole, and buried sinkhole [11].

Figure 3. The oldest and biggest sinkhole in study area.

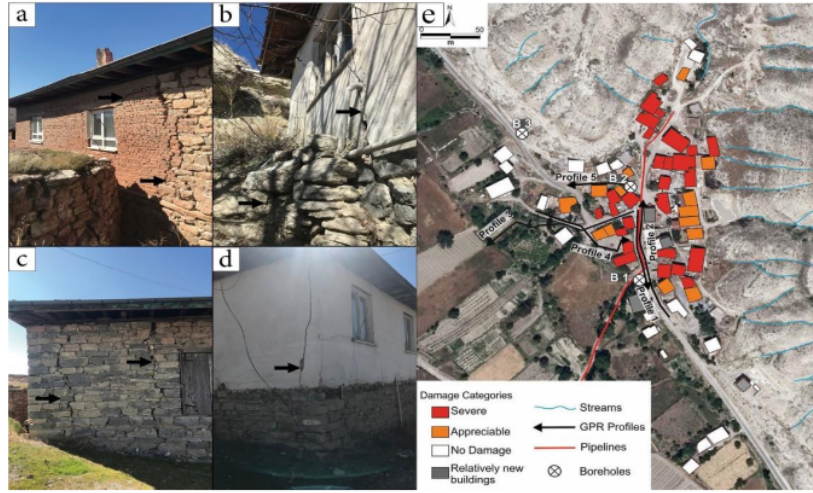
Within the scope of field studies, the damages of the buildings in the settlement were examined on site [11]. According to the information received from both the local people and the official institutions of the province, the most recent sinkhole formation occurred in 2012 [4-6-11]. Especially after the formation of the last sinkhole, the damage observed in the structures and the anxiety of the local people have increased (Figure 4).

Figure 4. Images of damaged buildings from the study area [11].

A damage assessment study was carried out in the study area [6]. The buildings within the area were evaluated in 4 categories (Figure 4). These 4 categories are that; the buildings shown in red color represent heavily damaged buildings, the buildings in orange color represent slightly damaged buildings, the buildings shown in white color are undamaged and the buildings in gray color represent relatively new residences. The dominant color scale is red and orange, indicating that most buildings are damaged.

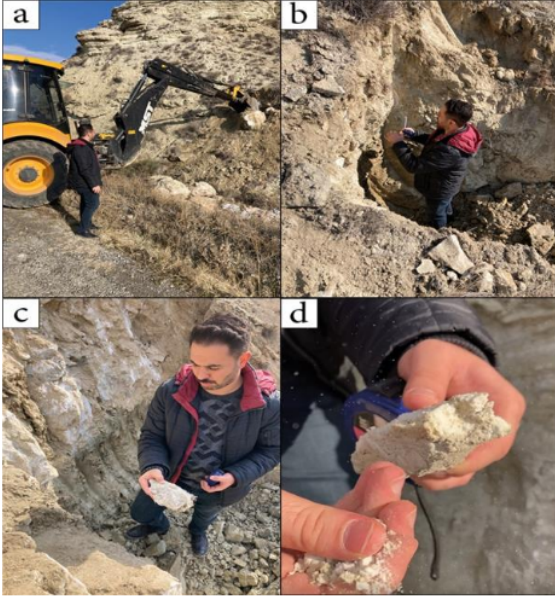
Figure 5. (a) A view from the exploration pit opening. (b) A view from Research Pit-1. (c) A view from Research Pit-2. (d) An image of the altered gypsum sample, which disperses even in hand [11].

Since the average Is₅₀ value found is less than 1 MPa, the rock class was determined as "very low strength" when a classification was made according to Table 4.

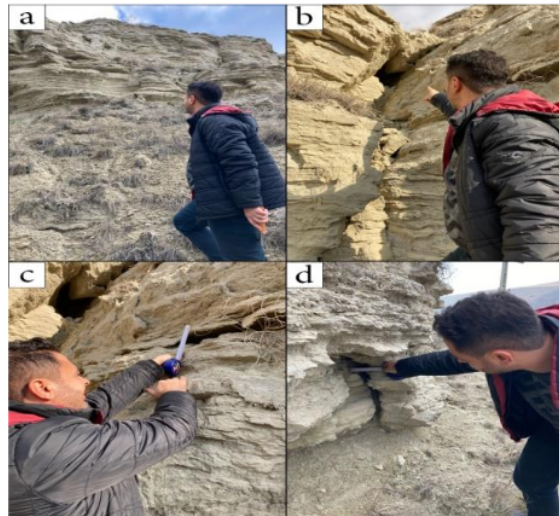
During the examinations made in the study area, some discontinuities were observed in gypsum units (Figure 6) [11]. While these discontinuities are sometimes in large sizes, they can sometimes be observed in small fractures. In all probability, the discontinuities observed are indicative of weathering in the rock and at the same time it is the harbinger of the decrease in the strength of rock. These discontinuities can sometimes take the form of a cavity, sometimes horizontally and sometimes vertically. The aperture values of the discontinuities are classified as defined in ISRM (2007) (Table 5).

Figure 6. (a) A view of the gypsum units in the study area. (b) An image of cavity resulting from dissolution in the gypsum

unit. (c) A view of the horizontal discontinuities occurring in the gypsum unit. (d) A view of the vertical discontinuities occurring in the gypsum unit [11].

Classification of discontinuities occurring in gypsum in the region varies as "voided structures" and "open structures" according to Table 5. Since the discontinuity in Figure 6(b) is considerably more than 100 mm, it is possible to define it as "open". Since the horizontal discontinuity observed in Figure 6(c) is around 50 mm and the vertical discontinuity observed in Figure 6(d) is around 80 mm, it is possible to define it as "extremely wide" [11].
